# Trailer carrying iron sheets collapses near Central

## Vehicle gets trapped after makeshift steel deck caves in

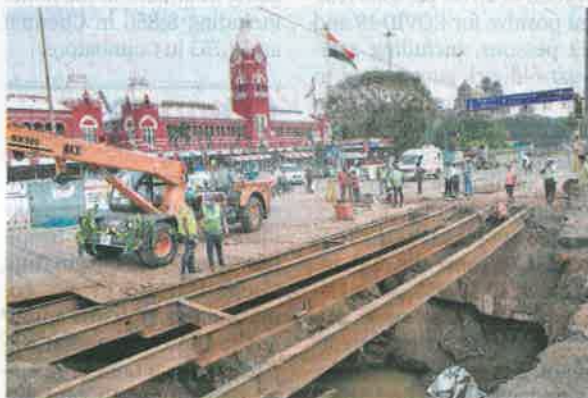
According to the police, as the truck, weighing around 60-70 tonnes, reached the spot, the deck caved in unable to withstand the heavy load of the trailer, and it sank into the hole.

**Restoring normalcy:** The caved-in deck on E.V.R. Salai near Central station being repaired on Monday. ■ S.R. RAGHUNATHAN

cluding that of the trailer, was 90 tonnes. The overloaded trailer damaged the decking plate, which collapsed.

Normal traffic resumed after authorities certified the rebuilt deck as fit for use by traffic, the police said. The Traffic Investigation Wing registered a case against the driver of the trailer for overloading.
